Staged Tests Increase Awareness of Arc-Flash Hazards in Electrical Equipment

Index Terms—Arc fault tests, arc flash, arcing, explosion.

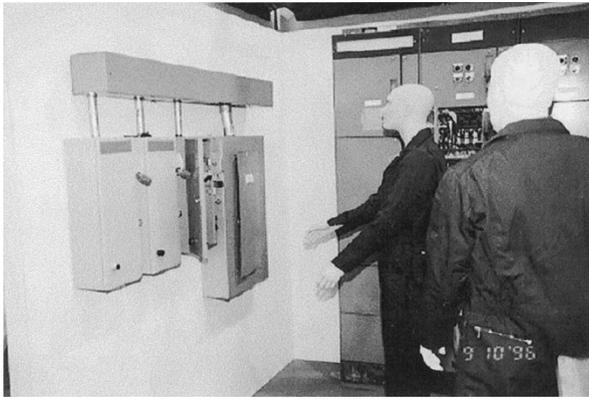
Fig. 1. Mannequins prior to test.

A preliminary series of 11 tests was performed on March 26–28, 1996. Subsequently, a series of 27 tests was conducted at the Paul Gubany High Power Laboratory, Ellisville, MO, from September 10–12, 1996. Two mannequin workers were positioned, as shown in Fig. 1. The mannequins were dressed in cotton shirts and pants, purchased from a local department store, and equipped with safety glasses, hard hats, and leather work gloves. The “lead” mannequin was closer to the electrical equipment, typically with the chest surface 2 ft from the fault and with one arm reaching toward the electrical service.

Thermocouples (Type-T) connected to an Astromed GE Dash-10 recorder were placed on the lead mannequin’s extended hand, neck front, and under its shirt at the chest. Thermal measurements of the mannequin surface were taken using infrared photography (Agema Thermovision Scanner 870 Catalog no. 556192904, Serial no. 4175 including monitor, control unit, power supply, dual lenses, and equipped with a Panasonic VCR) of the mirrored reflection of the mannequin. The infrared measurements were recorded on tape and reported for peak temperature observed (see Table III).

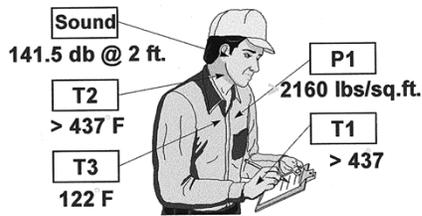
Fig. 2. Test 4 measurements.

pressure levels based on acoustic measurements. Table III summarizes the temperature observations, including infrared peak temperature recorded and temperature histories at the lead mannequin worker's hand (T1), neck front (T2), and chest beneath clothing or on the coworker (T3) 23–60 in from the arc source. Temperature histories included the peak temperature, rise time to reach 90%, 90% fall time, 90% to 80 °C, and 90% 70 °C for T1 and T2, peak temperature, 90% rise time, and 90% fall time for T3.

Arc propagation always moves away from the source; however, in the tests, arc escalation sometimes created upstream secondary faults. In the case of test number 4, the magnetic forces created by the flowing currents moved the wires upstream of the initial fault with enough force to damage insulation or tear the conductors from their terminations, creating additional short circuits. This was confirmed by reviewing the high-speed film recording of the progression of fault events. In test number 4, the upstream fault, created by magnetic forces was observed to be many orders of magnitude greater in destructive energy than the staged “low-level” fault.
